Technical Report

Impact resistance

Re: Fatigue test in compression related to the resistance to the impact on a fender made of Ethylene-vinyl acetate polymer, model ref. B.100 E.V.A. Bumper, fixed on a wood table with bolt 8x80mm and washers

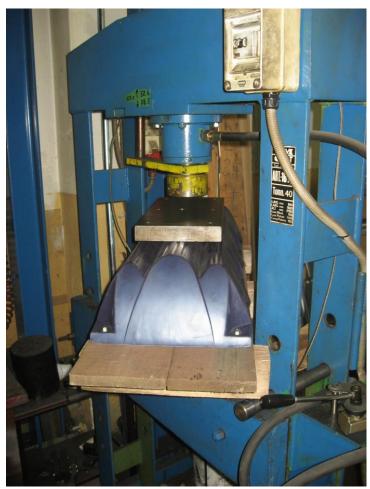
photo 01

Test realized with a hydraulic press of 40 tons and a flat stainless steel punch plate 55*22 cm.

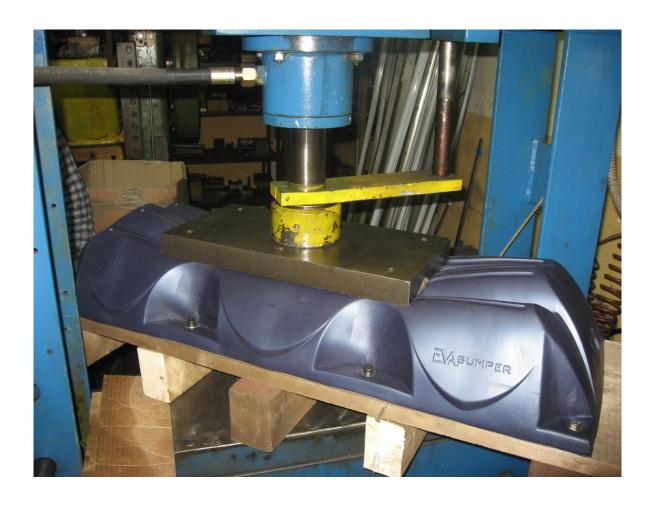
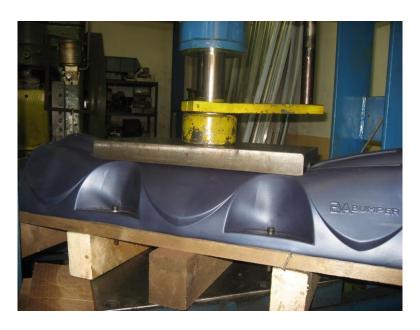
Photo 02

- 1) The press has begun a first compression of 500 kg / 5 KNw and the punch in the fender is penetrated for 2 centimeters, making to compress only the first leaning hump.
- 2) the next pressure of 1.000 kg / 9,80 KNw has begun the deformation of the fender and the punch has begun to penetrate the fender for 4 cm (photo 02)

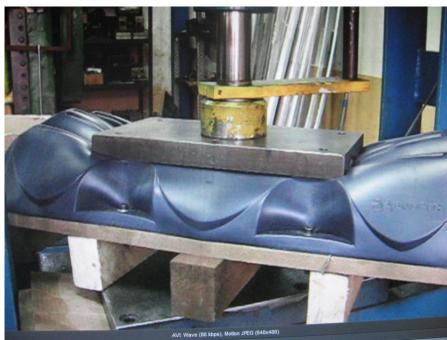
photo 03

3) the pressure has been increased to 2.500 kg / 24,51 KNw and the punch has penetrate the fender for 6 cm (photo 03)

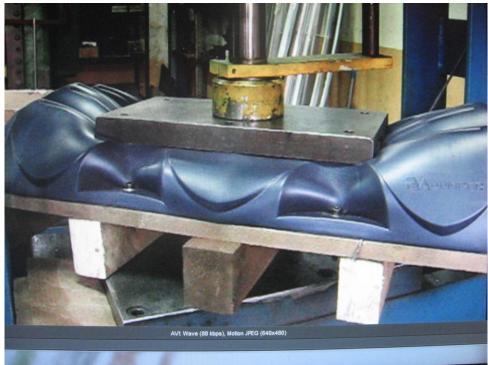
photo 04

4) the pressure has been increased to 3500 kg / 34,32 KNw and the punch has penetrate the fender for 8 (photo 04)

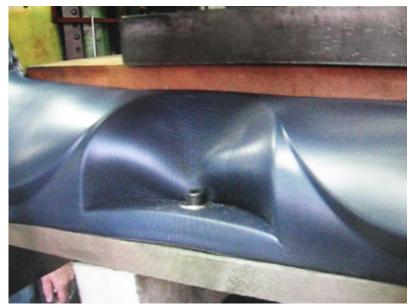
photo 05

5) Then the test will be repeated using a bigger surface of impact, wood table 22 * 75 cm the pressure has been to 3500 kg / 34,32 KNw and the punch has penetrate the fender for 7 cm. (Photo 05)

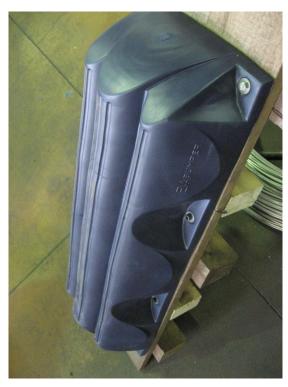
photo 06

the fender after an initial phase of light deformation, it returns to his initial form. Also the points of fixing have not introduced breakups after the perpendicular tests of compression. (Photo 06)

After these tests of compression, the fenders have not suffered perennial deformations, there have been no cuts or yieldings or tears.

This E.V.A. Bumper ref. B.100 have reached and excellently passed the compressions resistance of 34,32 KNw without introducing any type of yielding.
